**ALABAMA HAZARDOUS WASTES MANAGEMENT AND MINIMIZATION ACT
(AHWMMA)**

Compliance Evaluation Inspection (CEI) Report

Rehau Auto LLC & Rehau Construction LLC (Rehau)
2424 Industrial Drive SW
Cullman, AL 35055
EPA ID Number: ALR000000612
NAICS Code: 326199
Website: www.Rehau.com

12/2/2019

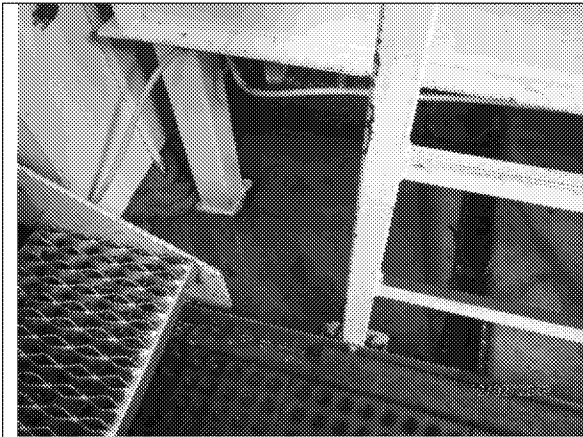
There were three mop buckets on the floor with oily water in them. The contents of the buckets will be poured into the oil/water separator, according to Mr. Mullaney. One 300 gallon tote of used hydraulic fluid was observed on a transfer platform. This platform also served as the secondary containment for the tote and it was completely filled with oily water. One 55-gallon drum for used oil was observed open and not labeled with the words "Used Oil". No other concerns were noted in this area.

Used Oil in Secondary Containment

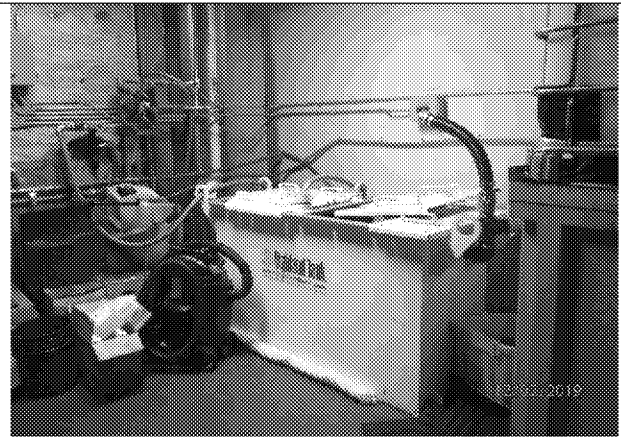
Oil/Water Separator and one mop bucket containing oily water

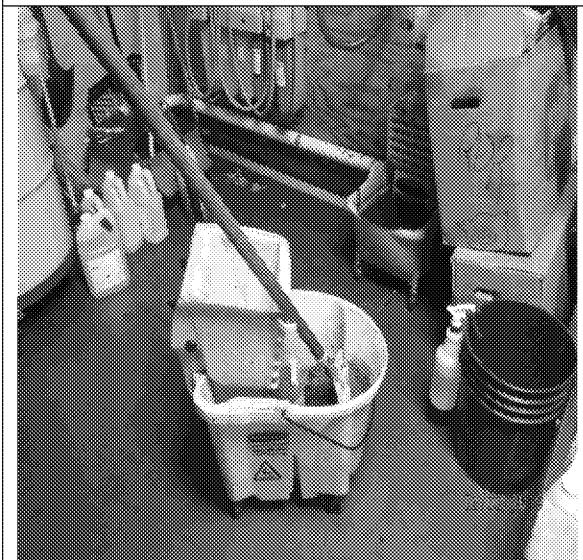
mop bucket containing oily water

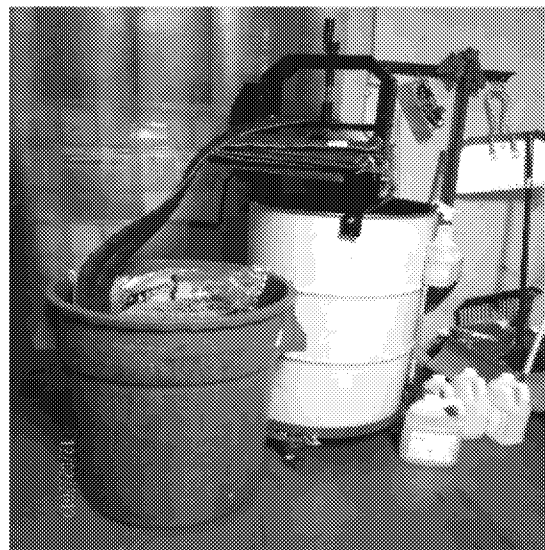
Absorbent pads satellite accumulation

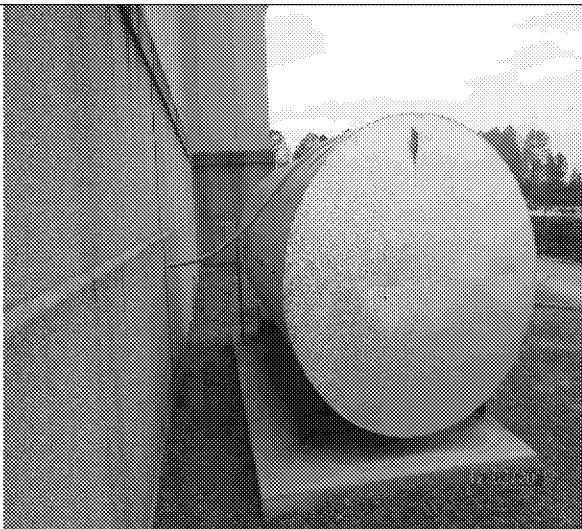
The used oil storage tank is adjacent to the oil/water separator room on a concrete pad on the outside of the building. The tank is approximately 10,000 gallons. The tank was not labeled with the words "Used Oil", but was in good condition. We noticed a small puddle of water between the storage tank and the building. There was visible staining in the relief joint of the wall behind the storage tank. It appears that used oil had reached the environment at some point and may still be present according to the sheen on the water in this area. Mr. stated that he would investigate the issue. No other concerns were noted in this area.

Staining on the soil behind the used oil tank

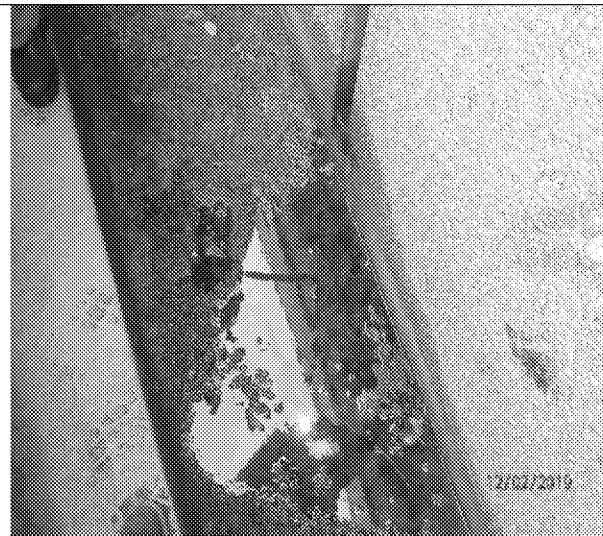
Staining in the building joint

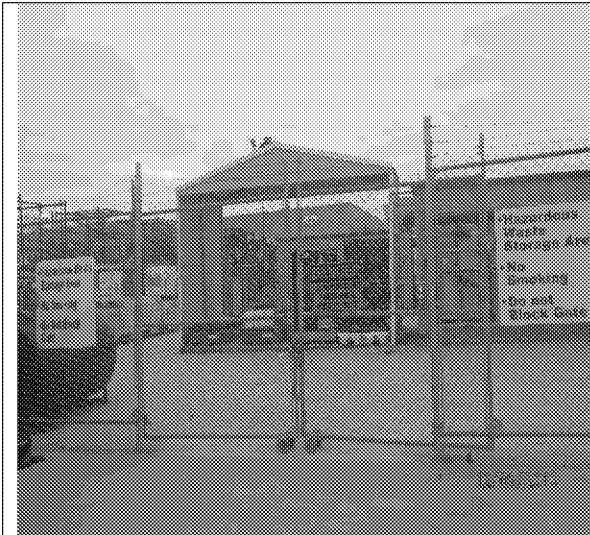
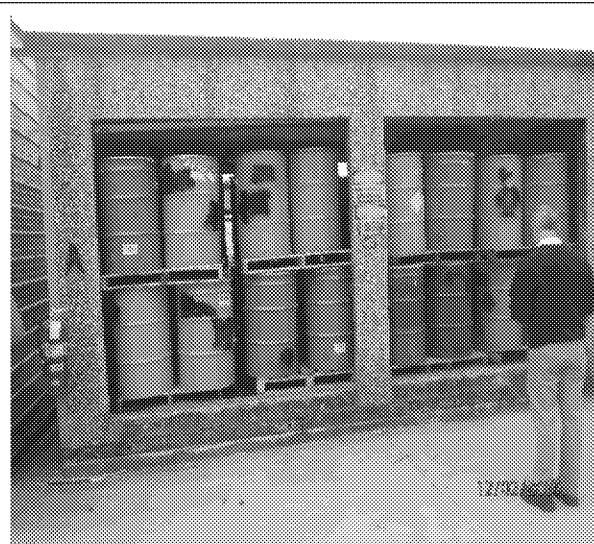
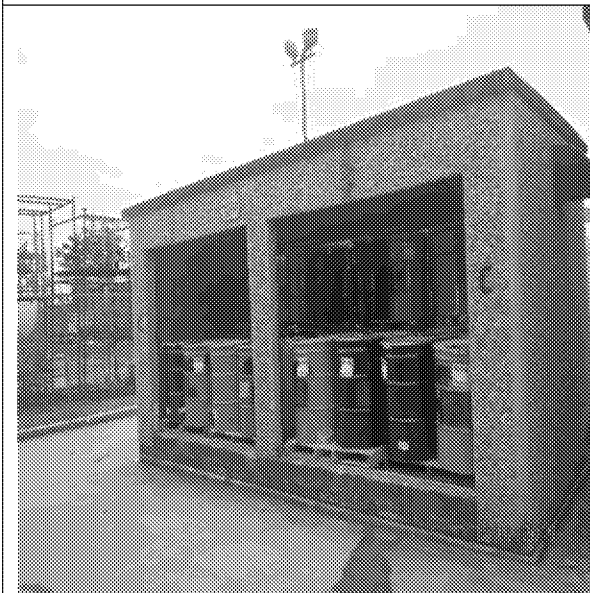
Hazardous Waste Storage Area

The hazardous waste storage area is also located on the south side of the facility in a fenced area outside. The area has the appropriate signage at every approach and has a means to control access to the area. There were fifty-five 55-gallon drums, one 300-gallon tote, and four 3-gallon buckets of hazardous waste in the area. All of the containers were closed, labeled, dated, and in good condition. The oldest container was dated 9/14/19. The secondary containment appeared to be in good condition and was free of any cracks or gaps. No areas of concern were noted in this area.

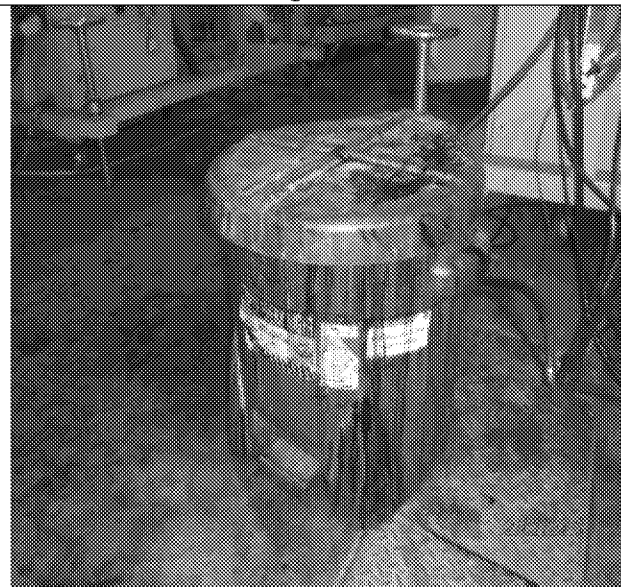
In this area, plastic pellets are extruded into hollow tubing of varying diameters for various application. There was one 55-gallon drum designated for hazardous waste at the beginning of the line. The drum was labeled, but not closed. This area has approximately twelve production lines with a 5-gallon satellite accumulation container at the end of each line. All of these containers were missing the words "Hazardous Waste". No other areas of concern were noted in this area.

Satellite Accumulation Container; PEX II ne
